**Damage to Drinking Water Systems  
and Restoration Measures  
after  
the Great East Japan Earthquake and Tsunami**

**July 2011**

**The Japan Water Research Center**

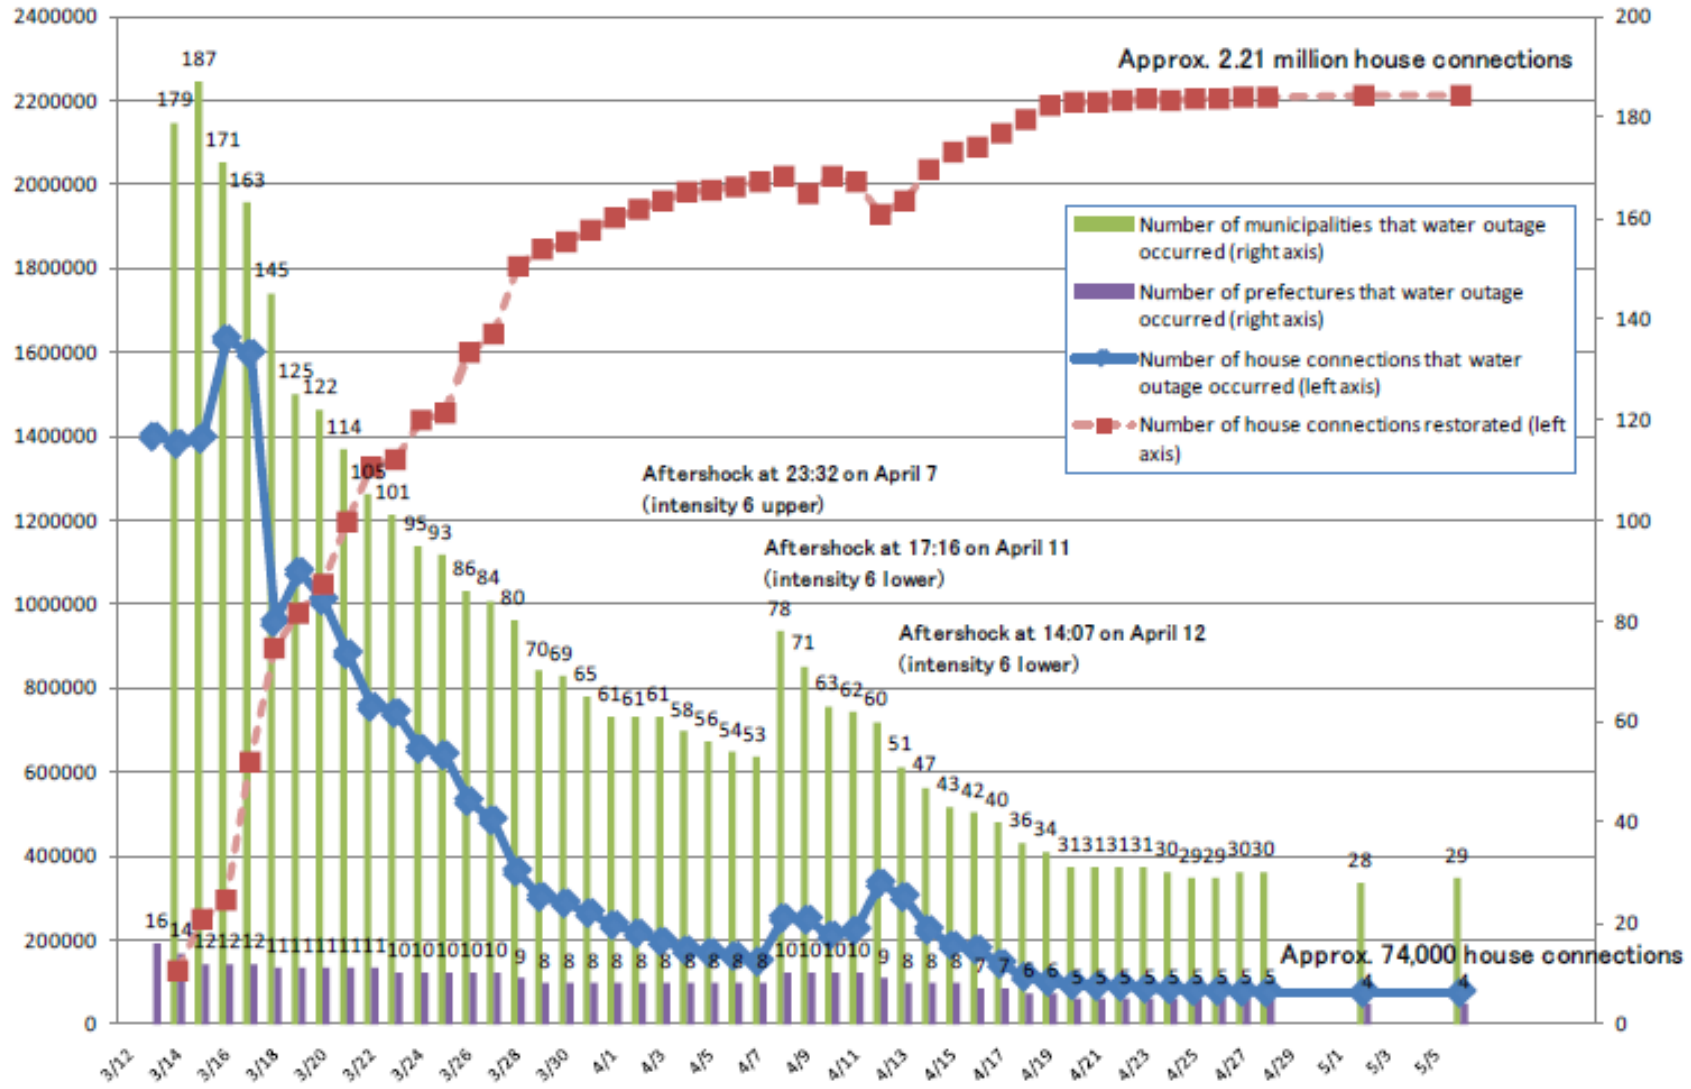
# Water Outage by the Great East Japan Earthquake and Restoration of Water Supply

(Number of house connections)

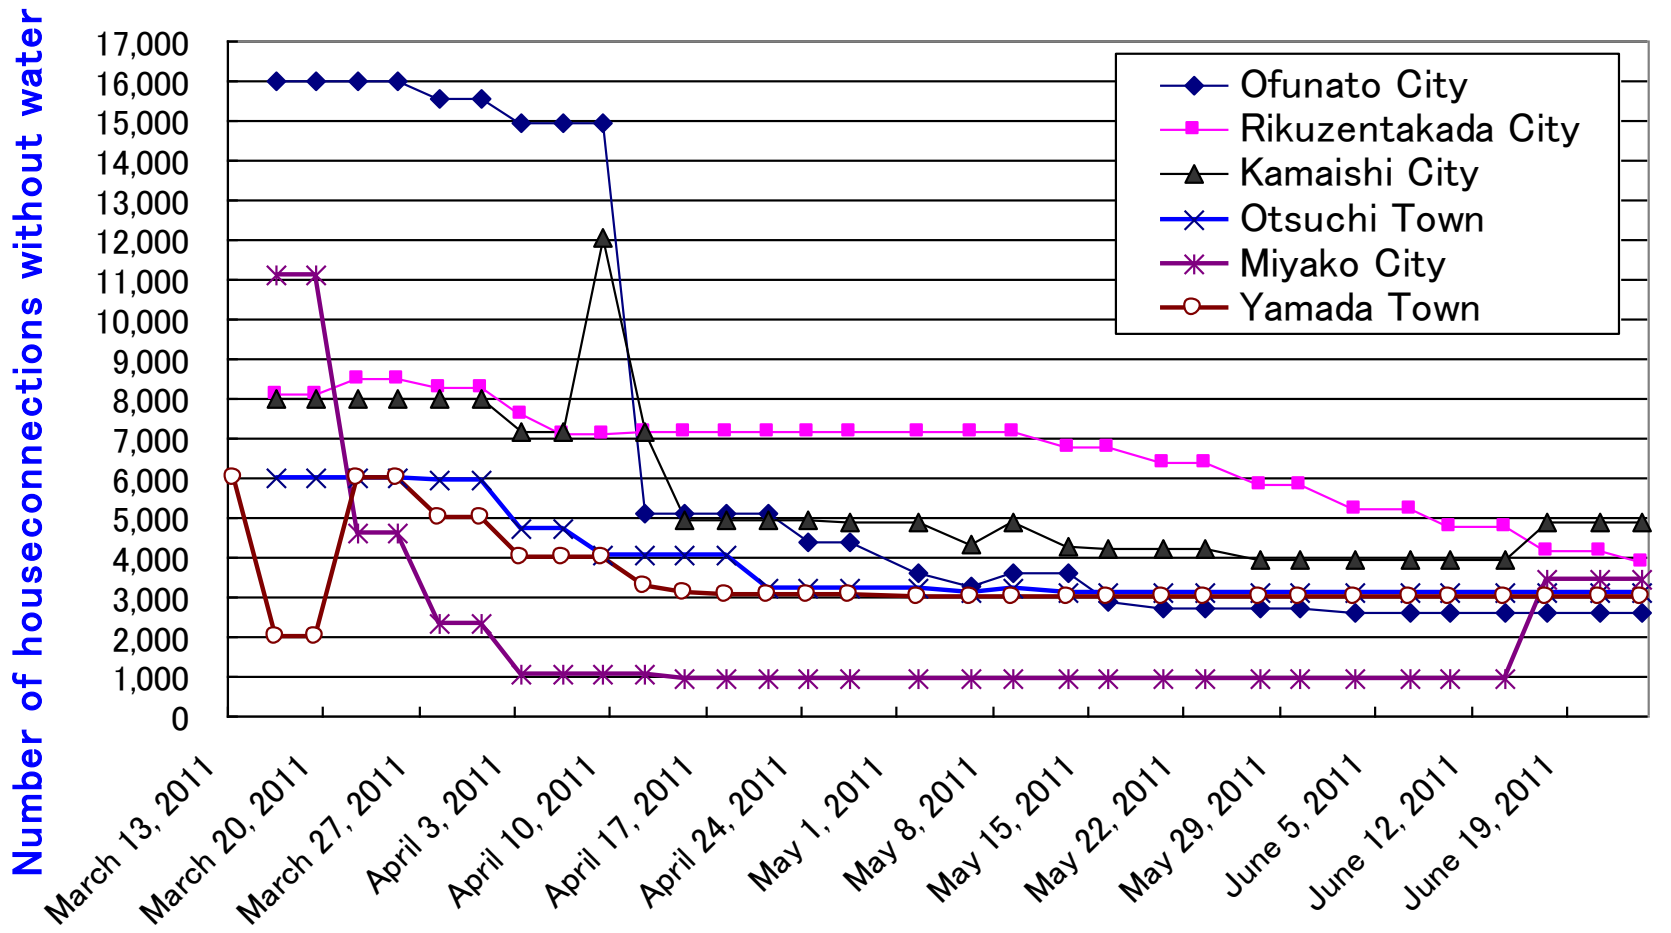
Water outage due to the Great East Japan Earthquake  
with Tsunami in Iwate Prefecture

Note : The water supply recovered early during a month after the Earthquake in the areas not affected by tsunami while it has still been suspended in the most tsunami-affected areas.

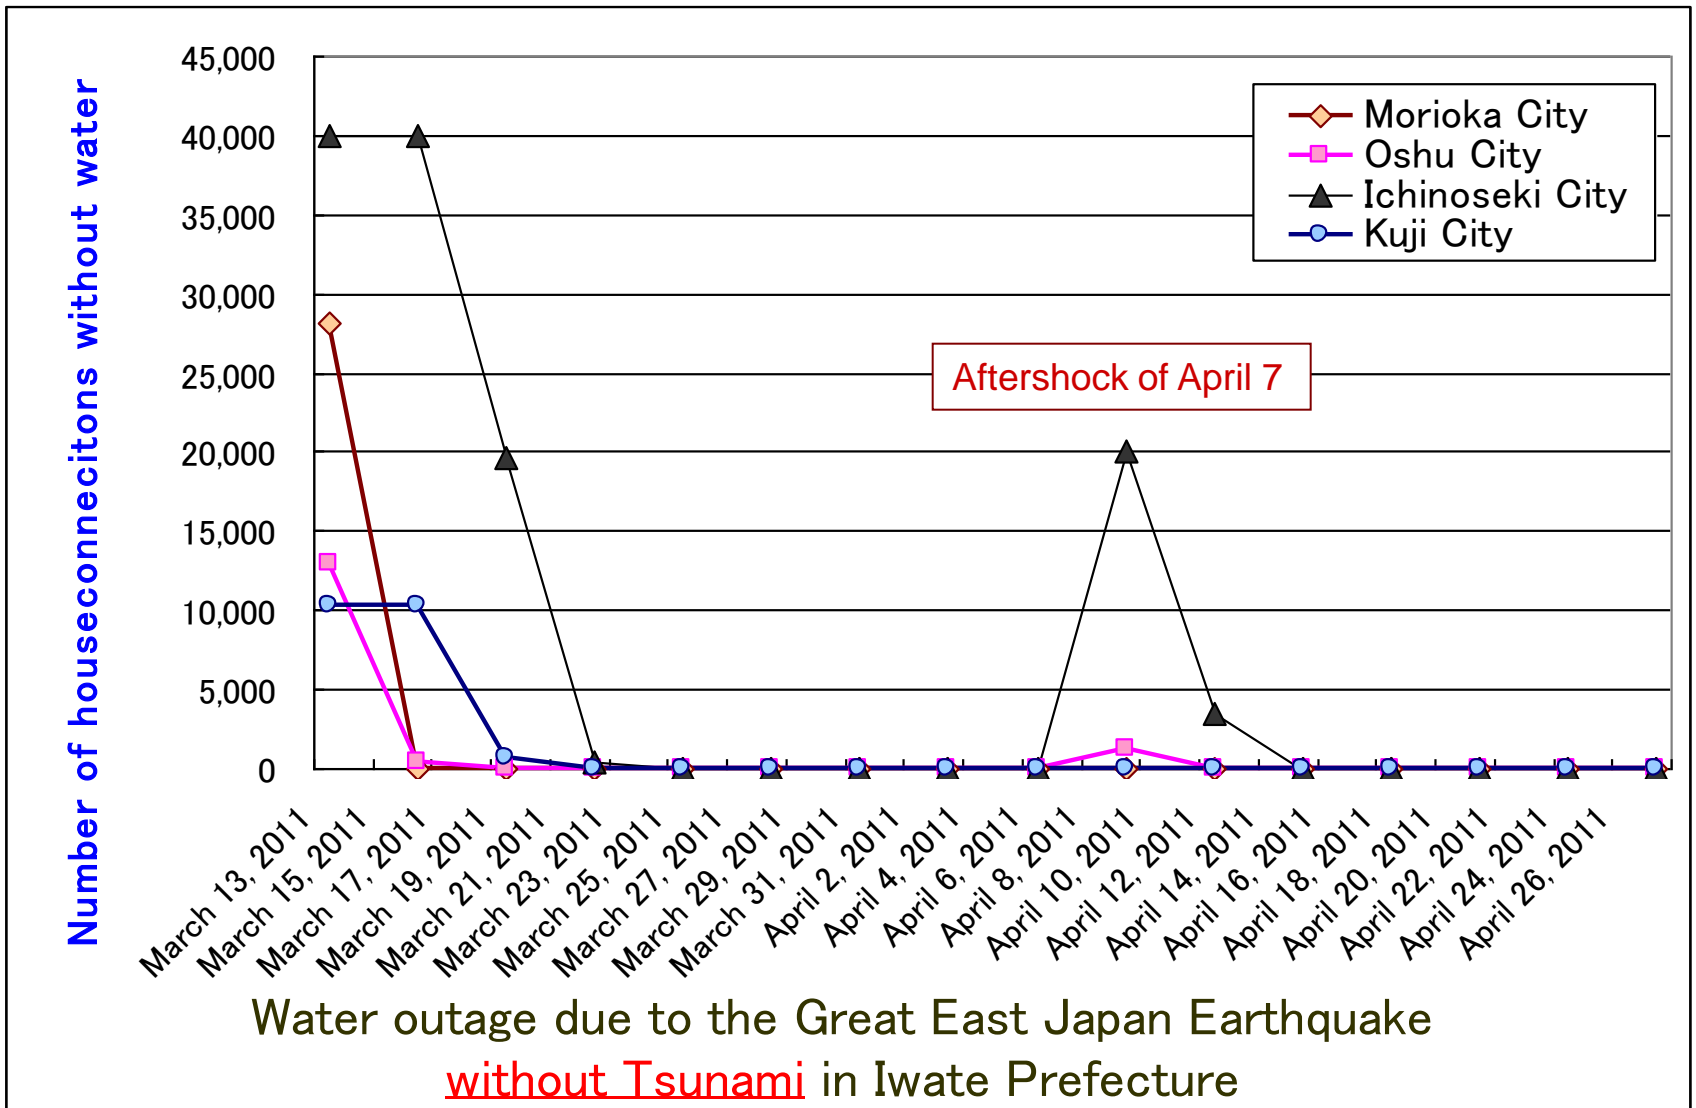
Note : Depending on the areas, the water supply was recovered about ten days after the Earthquake. An aftershock on April 7 left some areas without water supplies.

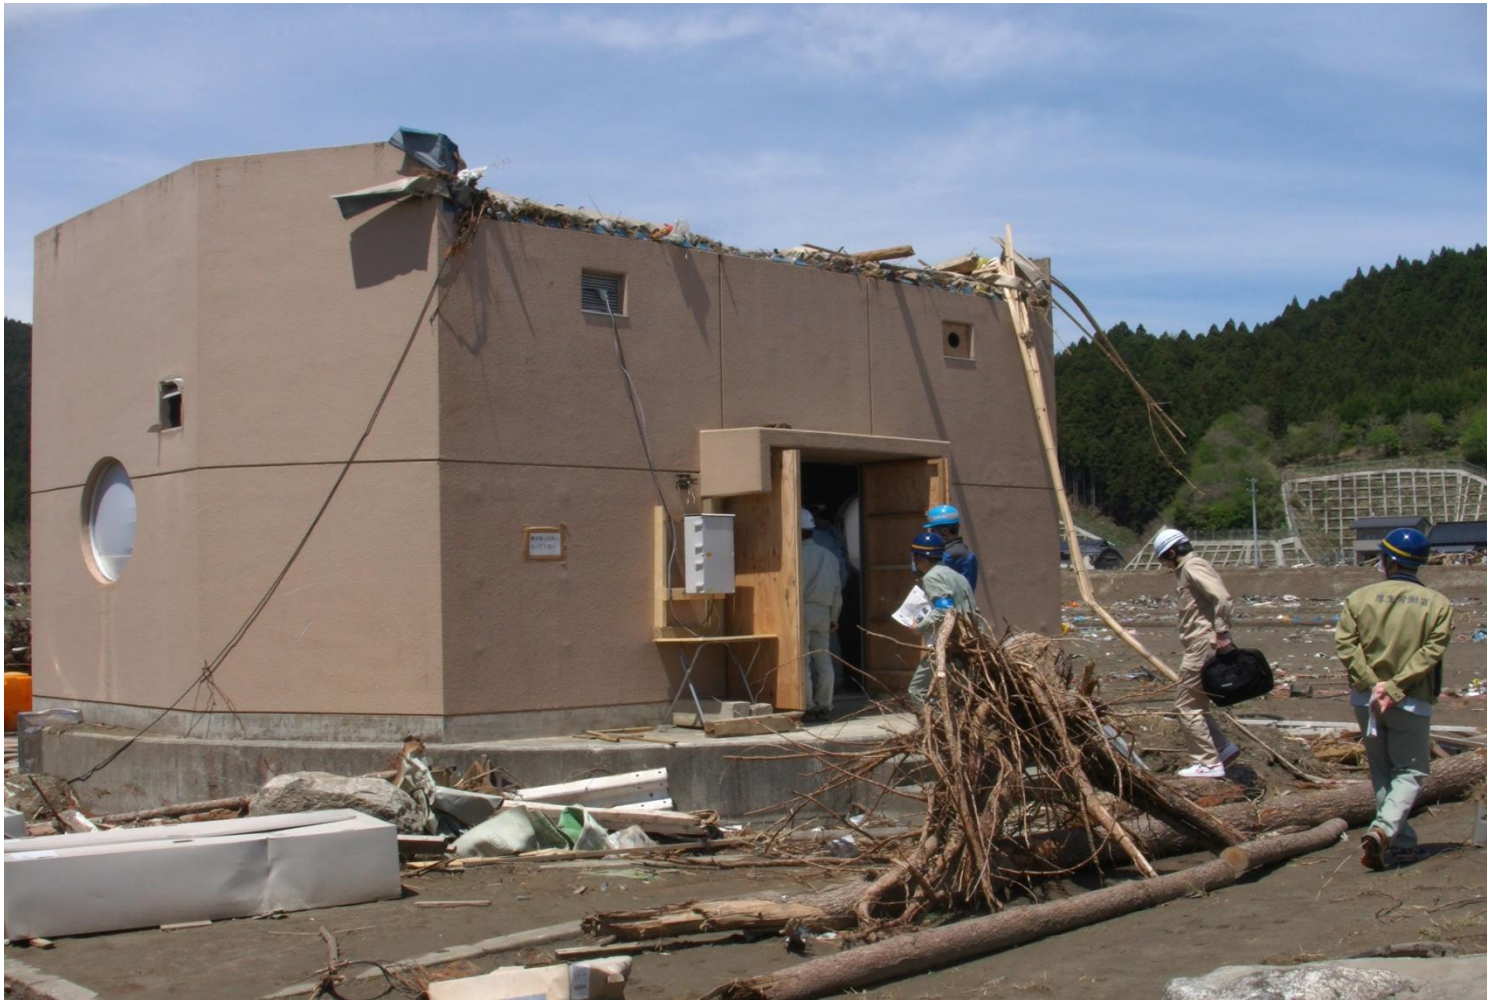
Damage due to Tsunami to Takekoma Treatment Plant of Rikuzentakada City

Note : The water source of Takekoma TP is shallow wells which were possibly salinized and contaminated by various substances.

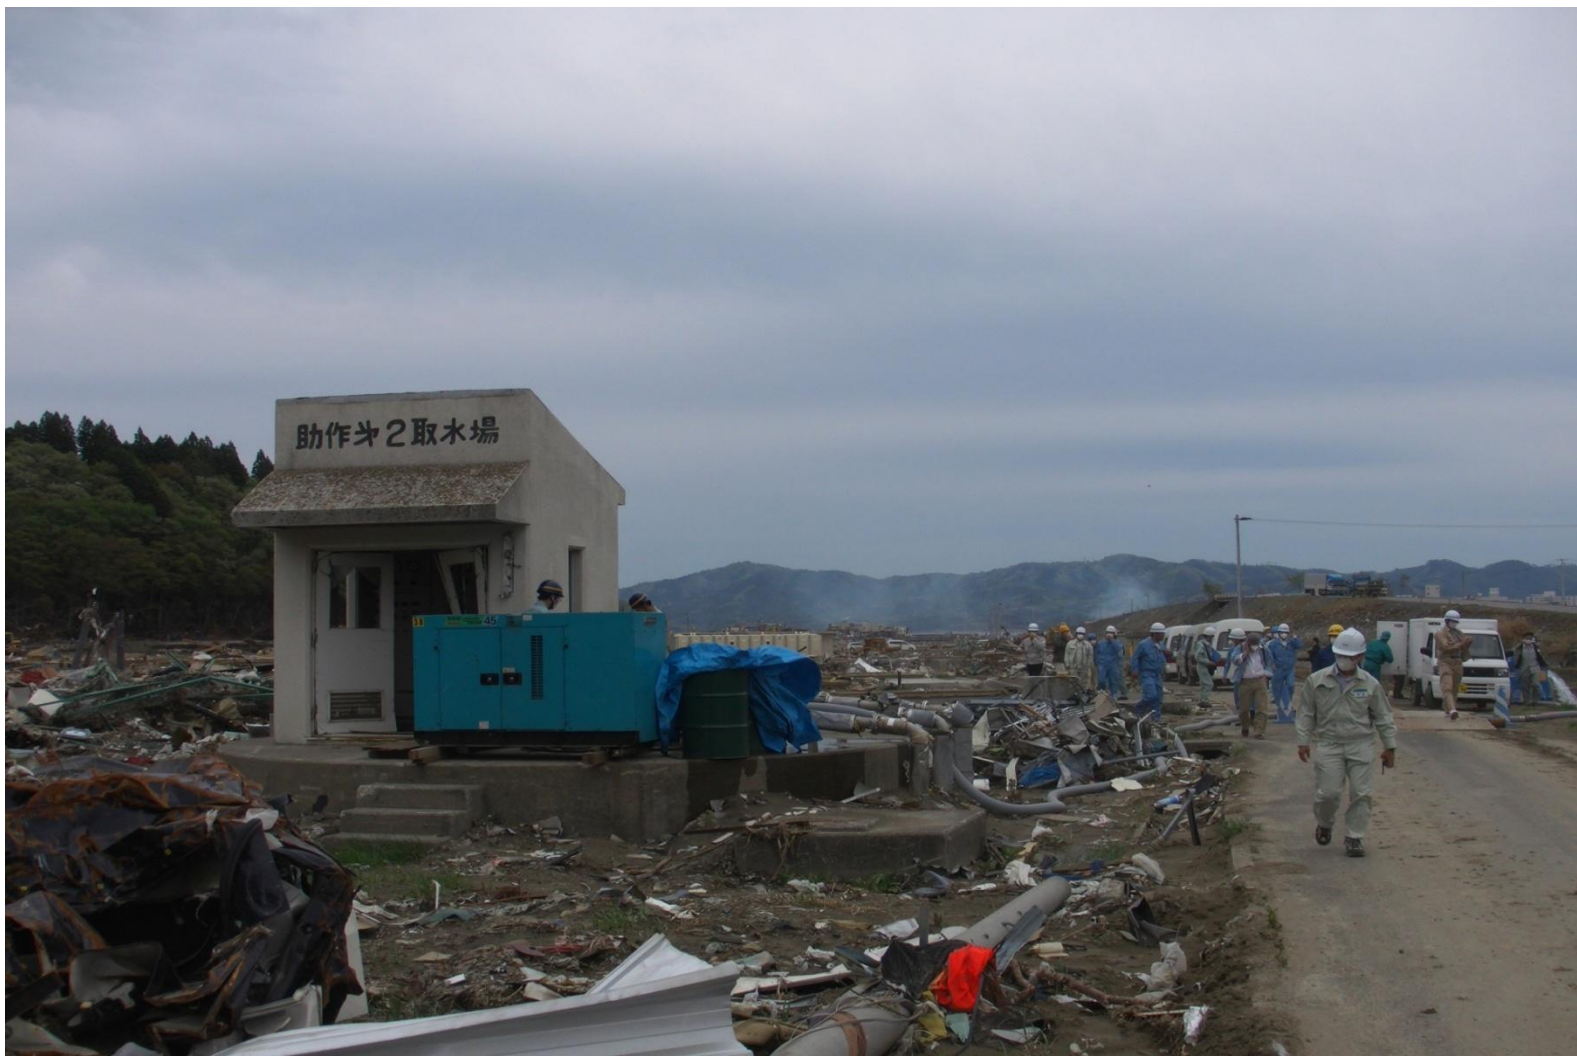
Damage to No.2 Sokedukuri Intake Facility in Minamisanriku Town

Note : The water source of No.2 Sokedukuri Intake facility is shallow wells which were possibly salinized.

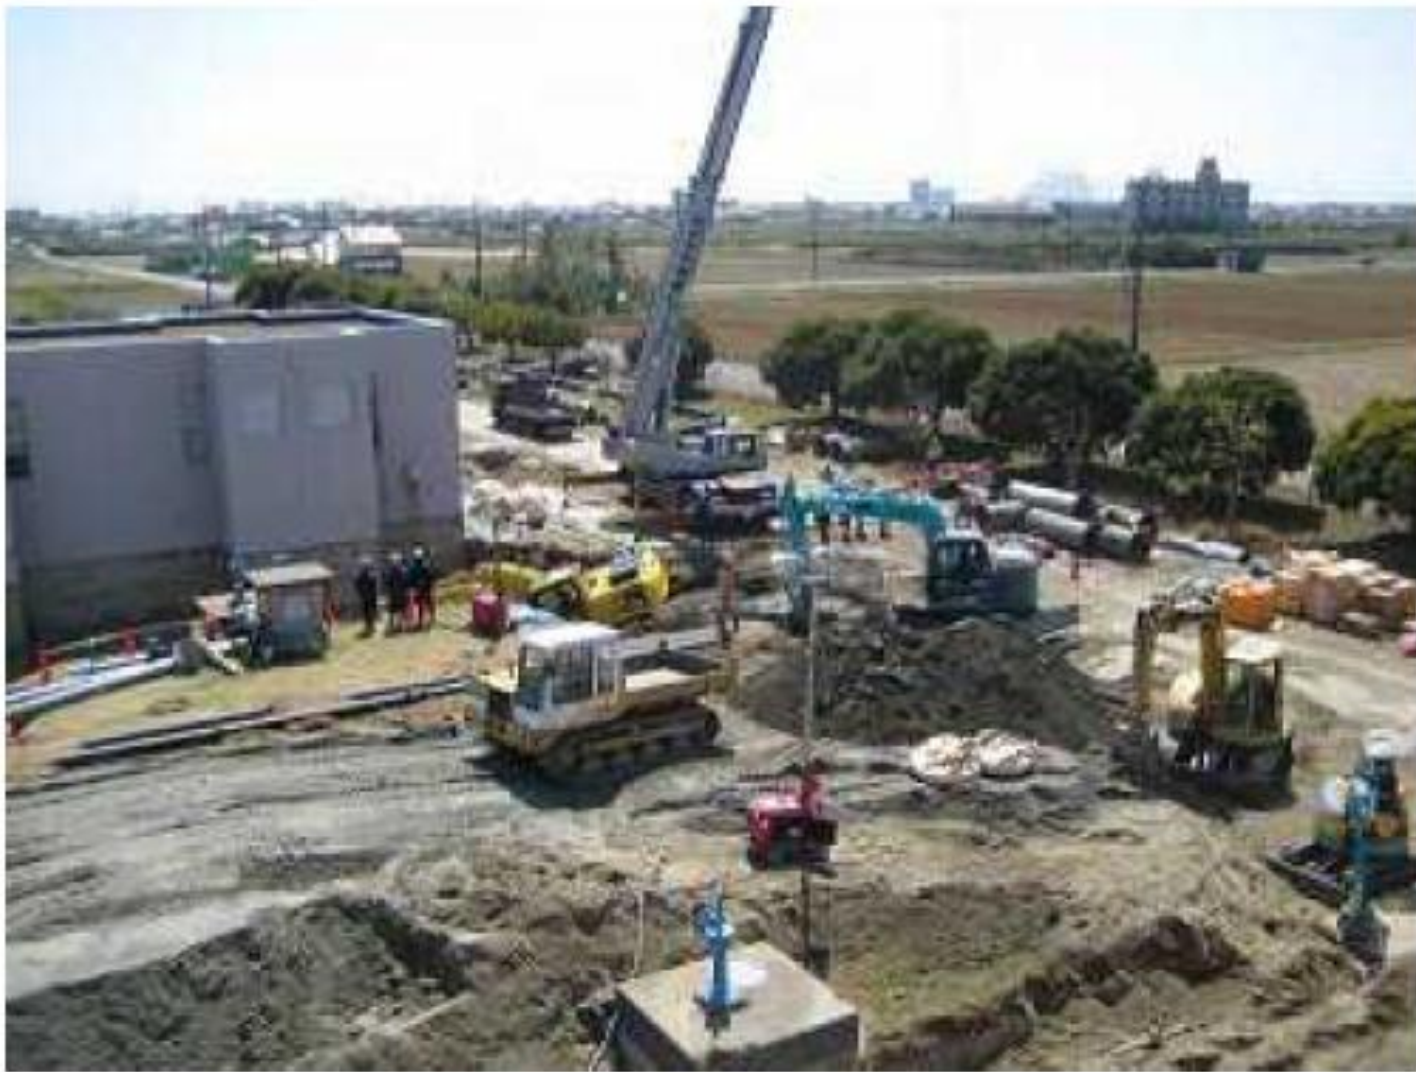
## Damage due to Liquefaction at the Wanigawa WPP in Ibaraki Prefecture
