# Kohalpur Small Town Drinking Water Supply Project

## Kohalpur, Banke, Nepal

### 1. Background Information

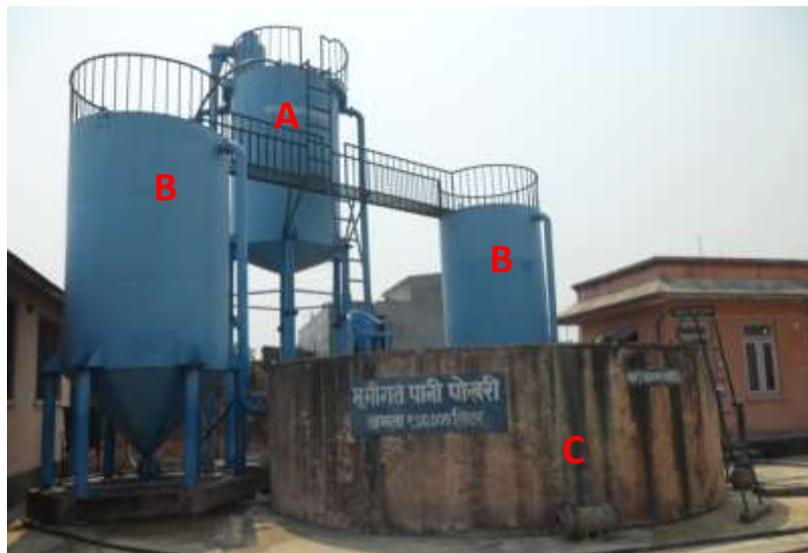
The components of KSTWSP is presented in the **Figure 2**, which consists groundwater pumping stations, vertical water aerator and sedimentation tank, sand filter, manual chlorination and storage in underground reserve tank, overhead tank and distribution networks:

**Figure 2: A – Perforated aerator (10 m<sup>3</sup>); B – Sand filters and C – Underground reservoir (100 m<sup>3</sup>)**

Water treatment system includes one Vertical Sedimentation Tank (**Figure 2A**) where the extracted groundwater passes through the perforated sheets and finally settles. The perforated plates contribute in aeration. The volume of the tank is 10 m<sup>3</sup> and have a diameter of 3 m and height of 5 m. The design flow rate of the vertical sedimentation tank is 36 L/s. The tank is cleaned every 7 – 15 days through the drain present at the bottom of the tank.

The water from Vertical Sedimentation Tank flows gravitationally to the sand filters (DynaSand® Filters). There are two units of DynaSand® Filters with the volume of 10 m<sup>3</sup> and diameter of 3 m. The designed flow rate of the filtration tank is 18 L/s. The filter is cleaned annually and the filter is equipped with automatic backwashing mechanisms which uses compressors for cleaning the filter. However, due to technical failures of the backwashing mechanism, the filter is currently being cleaned manually. The sand collected from cleaning operation is washed manually and reused in the filtration process. The wastewater generated during cleaning is discharged to the public sewers.

The clean water is stored in a ground reservoir of 100 m<sup>3</sup> volume. The chlorination is done manually at the reservoir. The dosing for chlorination is done according to 1 kg of bleaching power to 100 m<sup>3</sup> of water. The calculated contact time is approximately 15 – 16 min (Contact Time,  $T = V_{\text{eff}} \times \text{BF} / \text{peak flow}$ , Baffling factor = 0.2, flow = 20 L/s, Effective volume ( $V_{\text{eff}}$ ) = 100,000 x 0.95 L).

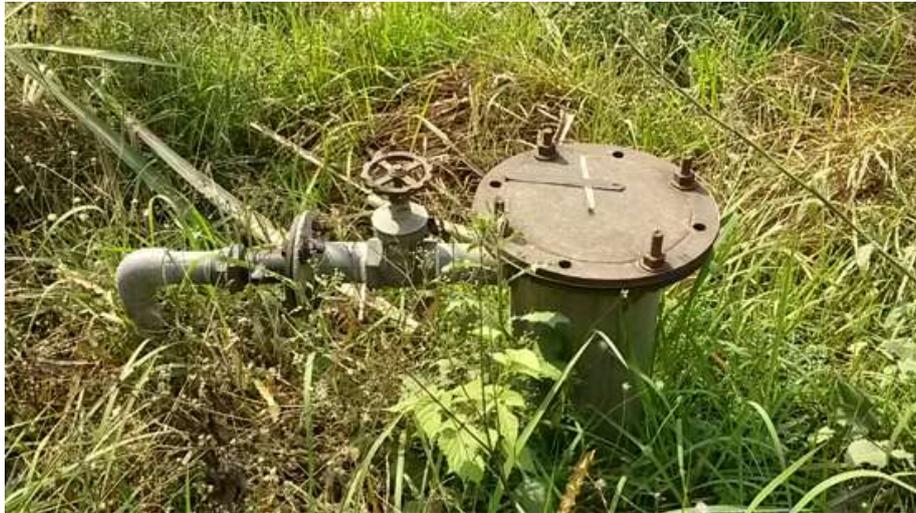
The groundwater is being used as a main source of water for the KSTWSP. The groundwater can be pumped from the six deep bore holes (details in **Table 2**). **Figure 3** shows one of the two bore holes and pumping stations located inside the water treatment facility while four are located about 2 km from the facility.

**Figure 3: Bore holes inside the water treatment facility**

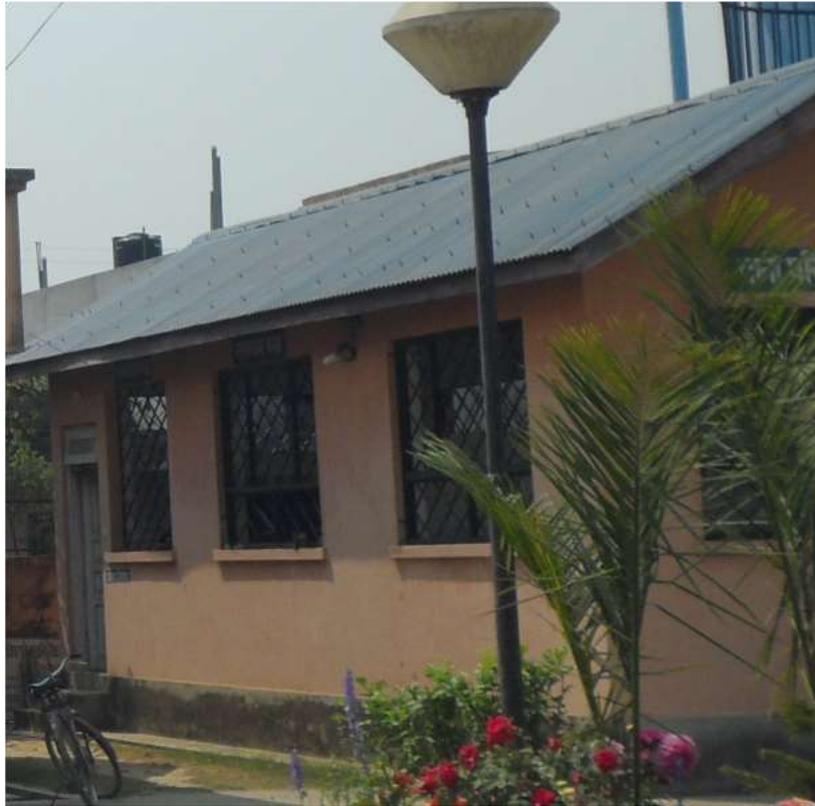
Besides chlorination, the treatment plant does not exclusively use any chemicals in the water treatment process. KSTWSP does not produce chemical sludge from the primary sedimentation process.

**Figure 4: Facility for the storage of chemicals**

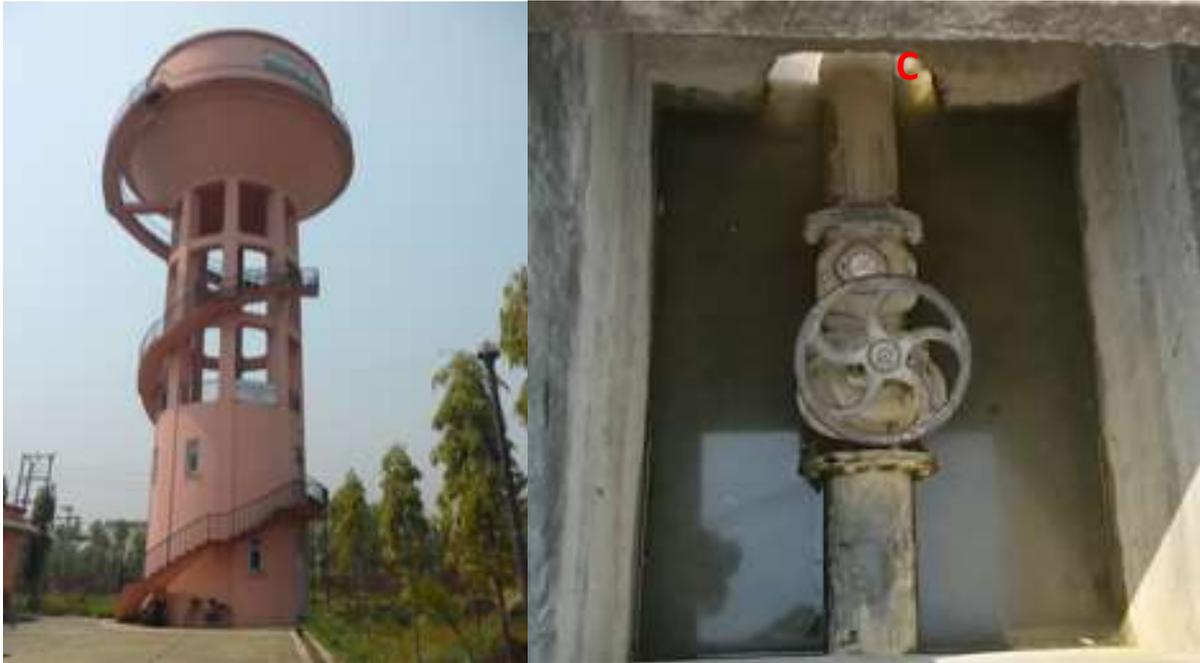
The clean water stored in a underground reservoir is pumped to the overhead tank of volume 450 m<sup>3</sup> and height 30 m (**Figure 5**) to create the service head. The water is then distributed to the residential areas. Besides the residential areas, Nepalgunj Medical College and nearby restaurants are among the highest consumers of the drinking water supply (about 43 m<sup>3</sup>/d).

**Figure 5: Over head tank of 450 m<sup>3</sup>(Left) and Gate valve for the water distribution network (Right)**

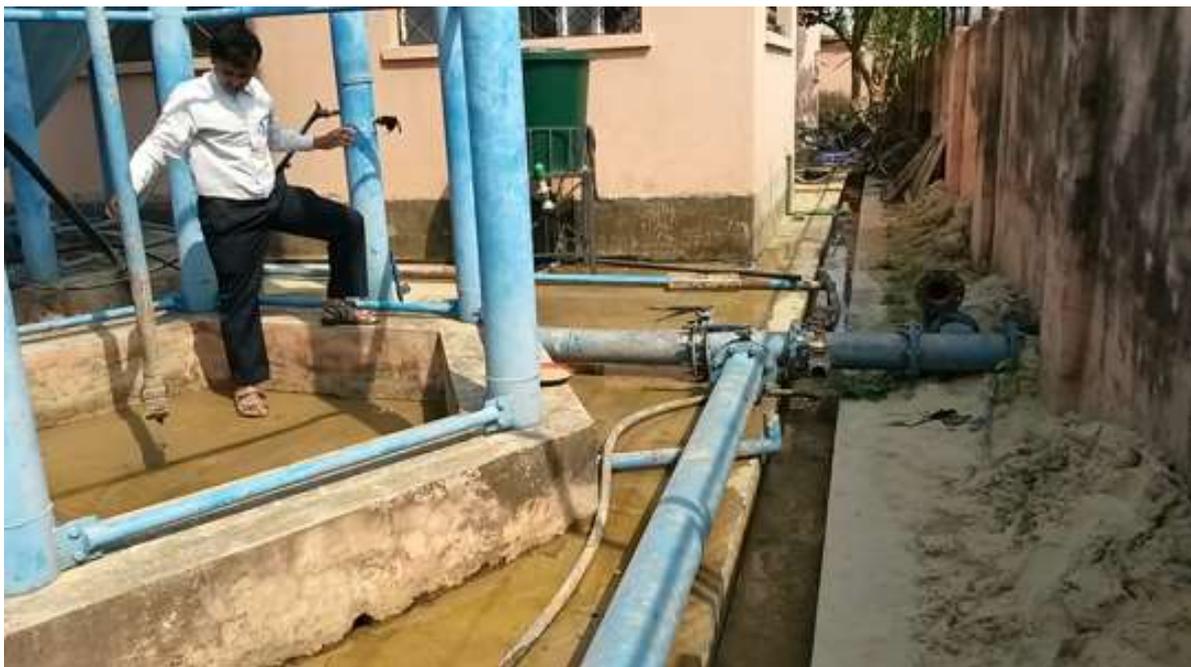
The primary sludge or sediments collected from the Vertical Sedimentation Tank is being disposed inside the water supply facility (**Figure 6**) temporarily and disposed nearby open fields and /or sometimes used as construction material for filling purpose. The KSTWSP does not have a sludge treatment facility. The wastewater used in cleaning operation is discharged into the public sewer systems.

**Figure 6: The silt deposit collected from the aeration tank**

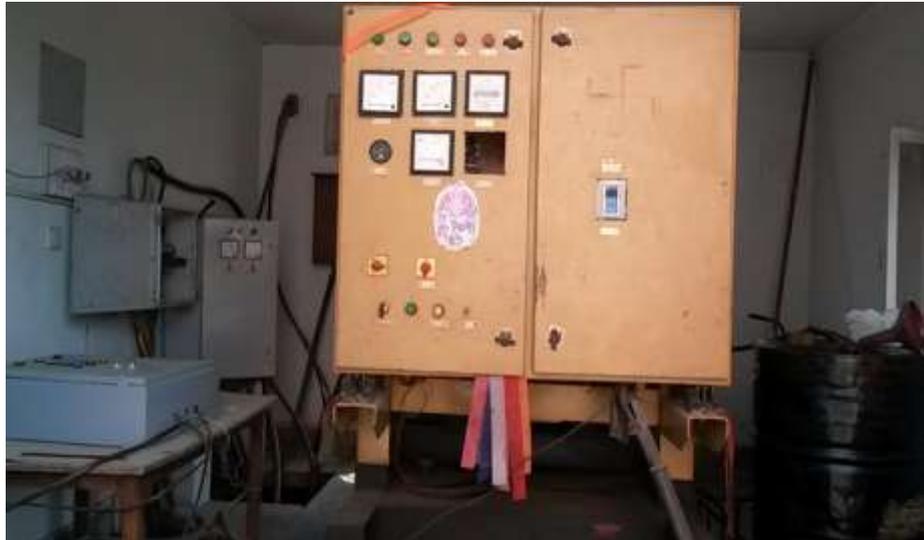
- The source of water for KSTWSP is mainly groundwater, therefore, the project relies on pumping stations for groundwater extraction. The Nepal Electricity Authority does not supply adequate electricity, therefore, the KSTWSP is forced to use fossil fuel (diesel) based electric generator (Figure 7) for the pumping and other operational activities of the water treatment plant.

**Figure 7: Generator (160 kVA) and electric switches for pumping stations**

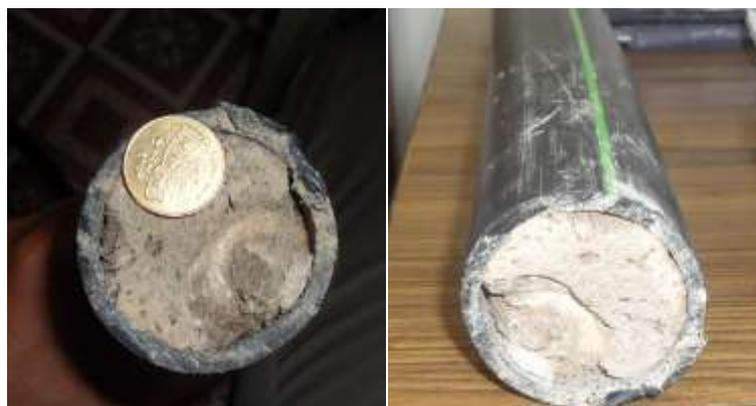
- KSTWSP spends large amount of the annual budget for the replacement of distribution pipes due to the clogging (Figure 8). The problem intensifies during the summer period (April – August).

**Figure 8: Calcification in drinking water distribution pipes (50 mm)**

For most the issues related to the issues (3) and (4) any measures have not been taken due to lack of budget. However, distribution pipes are frequently replaced as a measure to the calcification of pipes. Also KSTDWSSUA is planning to extent the service by increasing the capacity of the treatment plant.

The KSTWSP urgently needs a low cost water treatment plant for the removal of hardness to solve the calcification problems in the drinking water distribution networks. The KSTWSP needs following improvements:
